To Assess the Impact of Land Use Change on Nutrients Flow and to Establish the Level of Key Pollutants of Nyangores River

This study was carried out with the aim of assessing the effect of Riparian land use/ land cover change on the hydrology and water quality of the upper Mara River catchment specifically Nyangores River. The study incorporated remote sensing and GIS tools to prepare and analyze the data. It involved sampling of sediments deposits and water flows at various points of the river to quantify water quality parameters such as N, P, Ca and Fe etc. These parameters were tested in the laboratory.

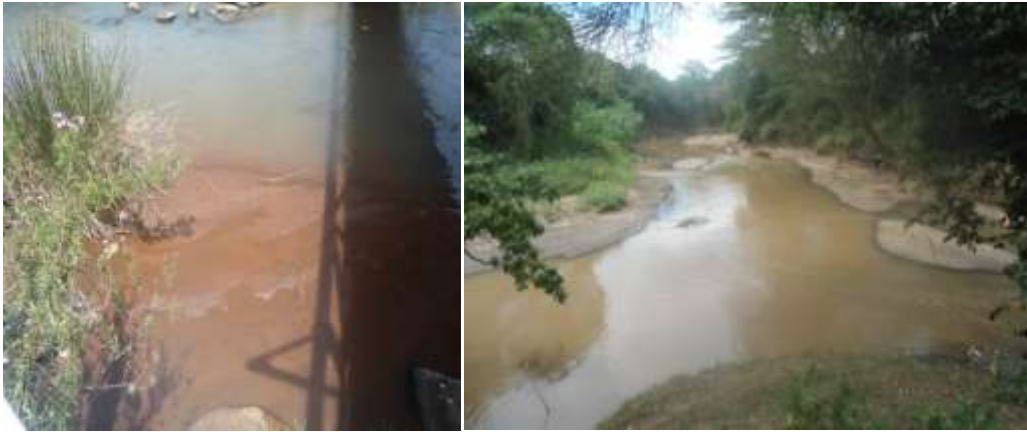
Figure.3.1: Shows lower Nyangores River heavily loaded with sediment

Digital image analysis for the riparian zone showed that between 1976 and 2003, crop land increased by about 100%, other vegetation and forests have reduced by 32% and 34% respectively with the river line decreasing by 50%. There is a continued decrease in the river line caused by declining quantity of water as a result of increased sediment in the river this is evident with figure 3.1 which shows accumulation of the sediment in the lower Nyangores River. The progressive increase in cropland and declining river line as shown in table 3.1 suggest that much of the natural riparian vegetation has been destroyed leading to sediment flow into the river.

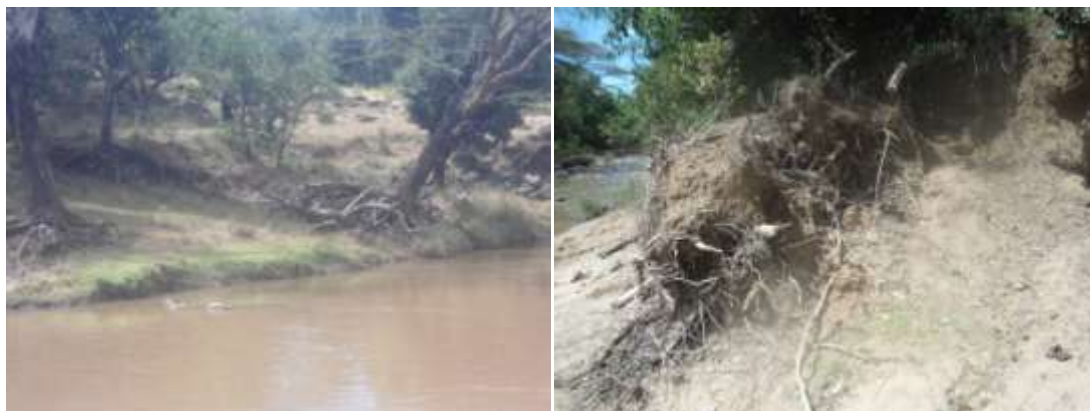
Figure 3.3: River banks of lower Nyangores River where trees have exposed roots caused by washing away of the poor cohesive sandy soil.

At the river bank elevation 1714m, S00⁰59'417, E035015'634 existence of exposed tree roots was observed which is a sign of bank erosion. Table3.4shows Soil collected at this point and tested for particle size analysis using hydrometer method and shows the following characteristics.

Sandy soils has a poor cohesion and they are therefore prone to erosion and hence the appearance of uprooted trees and exposed tree roots at this part of Nyangores river which has lead to lose of riparian vegetation as shown in figure 3.3.

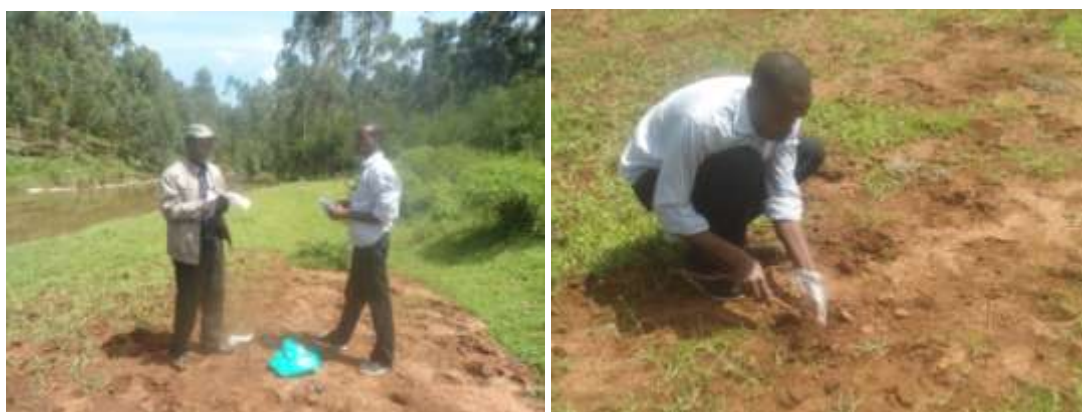
Figure 3.4: Shows sampling of soil sediments trapped by Kikuyu Grass along the river bank.

Table.3.2 shows the values of Ph, EC, N, P, K, Ca, %TOC, and Fe of soil deposit obtained from the river bed as well as the bank of River Nyangores. Location 3 and 4 represents a cattle track which is intercepted by a well protected river bank growing with Kikuyu grass as shown in figure 3.4 below. The soil shows a high Ph value of 5.4. P= 0.66, N=0.7, 6.4 %TOC and Fe=17mg/kg .This could be attributed to the channelization leading to urban areas as well as animal faeces. The Kikuyu Grass has a high trapping efficiency. Quarrying activities at location 7 as shown has a value of Fe = 27 mg/kg, Ca=22 meq/100 soil which is the highest of all other values. Cleaning of vehicles is major contributing factor to water pollution in Nyangores River. Water samples

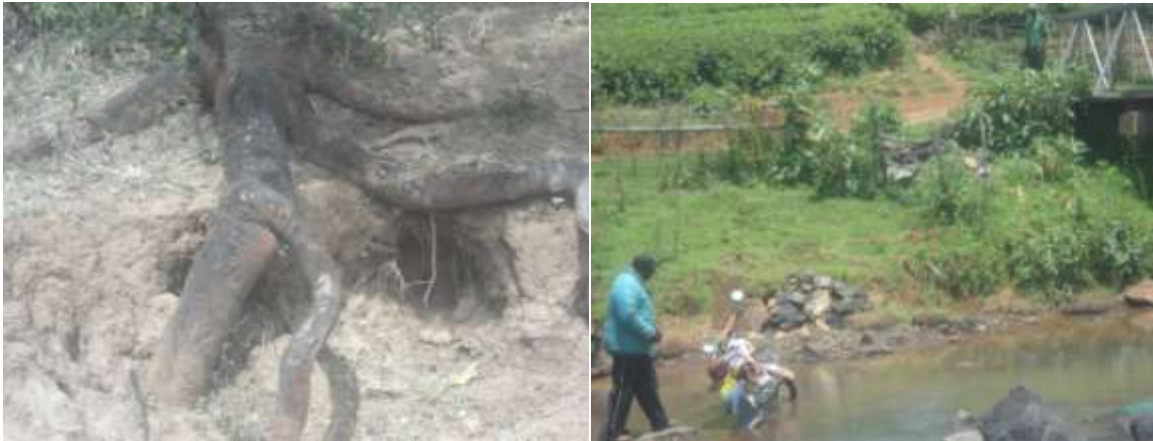
Profile of a large woody tree within the Mara River Watershed illustrates the intricate root system that works to stabilize soil. Cleaning of vehicles is also observed (Photo by F. Kigira)

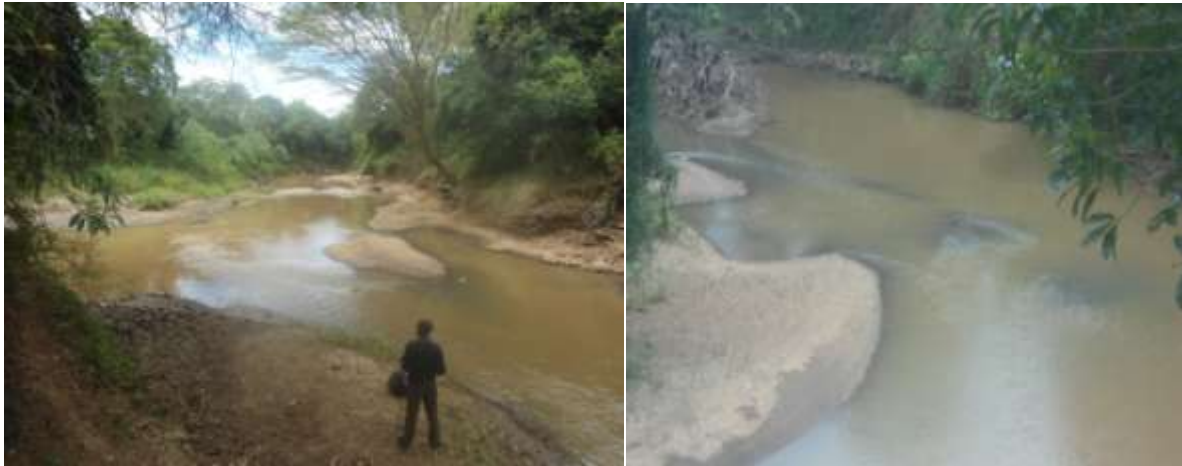
Sediment deposit downstream of Nyangores River reducing the River capacity.

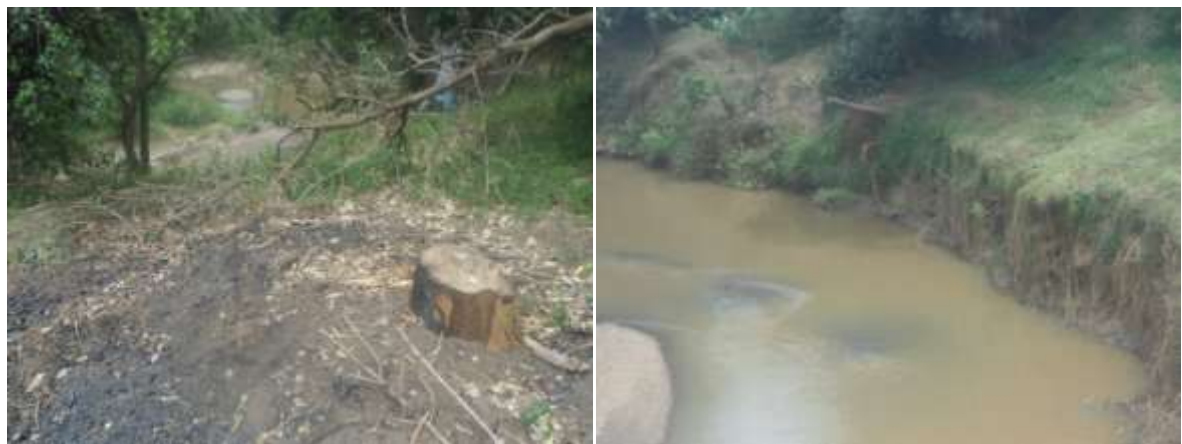
Burning of charcoal and destruction of river banks by livestock

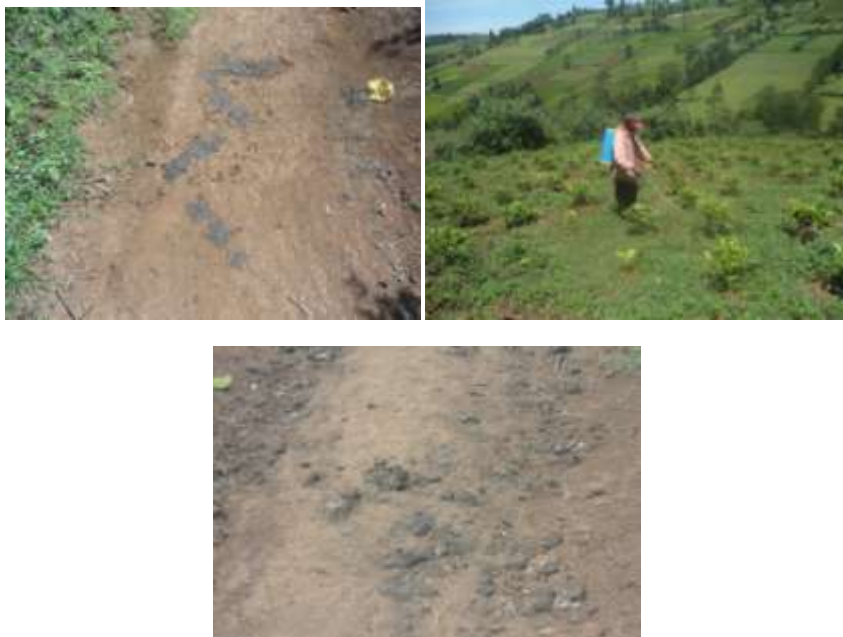
Animal waste and chemical application in agricultural activities also contributes to decline in river water quality
